The "AGING" Mechanism in Electron Multipliers and Operating Life

Aaron D. Cutter (1), Kevin L. Hunter (2), Peter J. K. Paterson (3) and Richard W. Stresau (1)

Presented at the 42nd ASMS Conference on Mass Spectrometry and Allied Topics
May 29-June 3, 1994, Chicago, Illinois

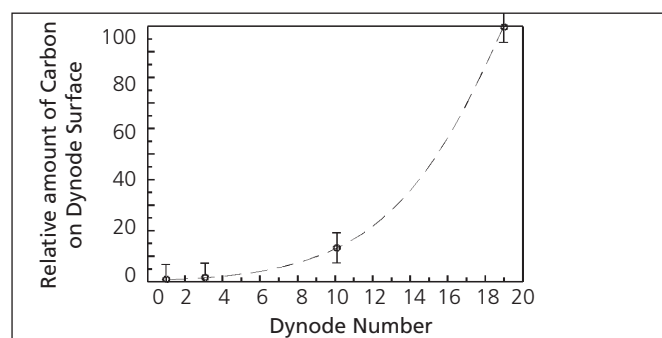
As would be expected, the dynodes closer to the output of the multiplier are exposed to much greater doses of secondary electrons than those dynodes closer to the input. The shape of the curve in figure 3 is very close to that seen in figure 1.

Figure 1. Relative level of carbon contamination on dynode surfaces (dynode #20: last dynode).

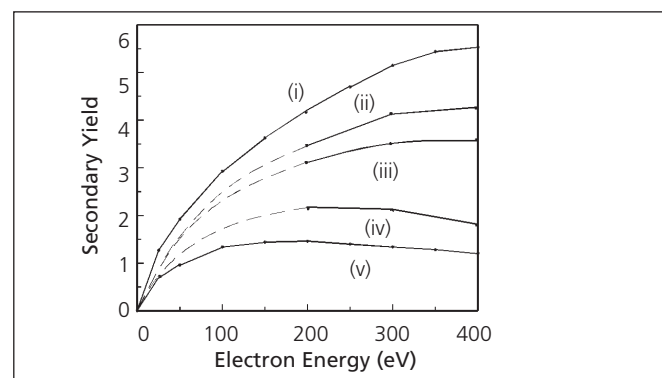
Figure 2. Secondary electron yield from (i) a new dynode surface of an active film Multiplier and those of an aged multiplier (ii) dynode 3, (iii) dynode 10, (iv) dynode 19, and (v) the surface of a specially prepared heavily contaminated dynode covered with a very thick carbon layer (for comparison).

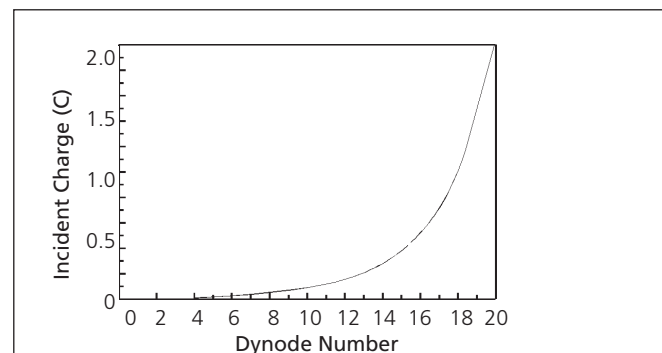
Using computer simulation techniques to closely model the operation of a discrete-dynode multiplier, we can estimate the total dose of electrons incident on the surface of each dynode (figure 3).

Figure 3. Theoretical calculation for the total electron dose incident on each dynode.

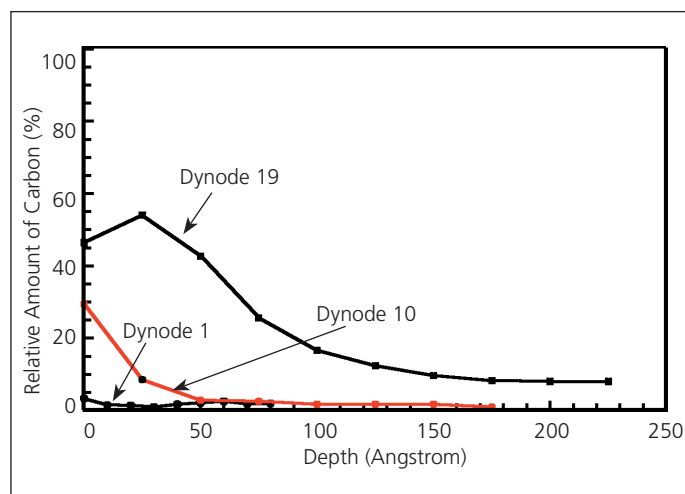
Analysis of the dynode surfaces was conducted using Auger Electron Spectroscopy (AES). The main contaminant observed on the dynode surfaces was carbon. Contaminant levels increased dramatically on the dynodes nearer to the output end of the multiplier (figure 4).

All the dynodes of the multiplier were exposed to the same environment for the same time interval. The only difference between the dynodes is the dose of secondary electrons they received during the accelerated aging process. This leads us to conclude that the dose per unit area of secondary electrons irradiating the dynode surface is the dominant factor governing the rate at which the dynode surface is contaminated.

Figure 4. Depth profiles, taken using Auger Electron Spectroscopy (AES), of the relative amount of carbon contamination on the dynode surfaces of a heavily used multiplier. Dynode 1 corresponds to the first dynode and dynode 19 is the near output.

- Since the process of aging is directly related to the total accumulated charge of electrons per unit area on a dynode surface, an obvious way of increasing the useful life of a multiplier is to increase the surface area of the dynodes. This spreads the electron dose out over a larger area, reducing the accumulated charge per unit area on the dynodes. This is particularly true for the dynodes in the latter third of the dynode chain where the secondary electron currents are much larger.
